FRAMINGHAM DOWNTOWN PROGRAMMATIC STUDY
TECHNICAL MEMORANDUM ON EXISTING CONDITIONS

Technical Memorandum #1 - Existing Surface Conditions/Deficiencies

Prepared by: The Cecil Group, Inc.
Prepared for: BETA Group, Inc. and
Town of Framingham

June, 2008

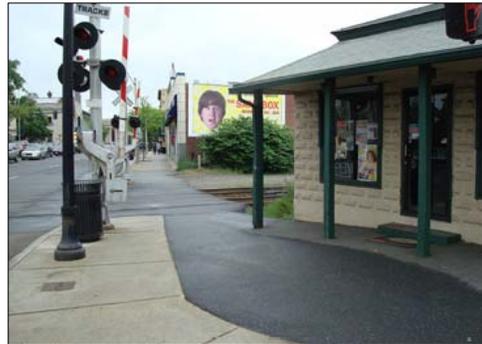
At the Hispano-Americana Record Shop on the northeast corner of the intersection, an 8 foot wide band of cement concrete pavement wraps around the corner and changes to bituminous concrete pavement on Waverly Street immediately east of the Waverly Street crosswalk. The area immediately adjacent to the record shop entry is also bituminous concrete pavement.

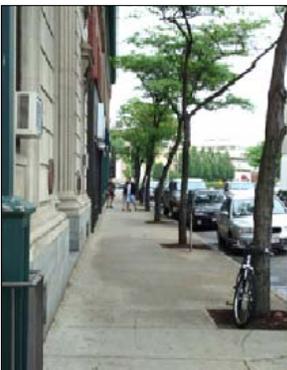
Pedestrian surfaces on Concord Street immediately north of the Waverly Street intersection are bituminous concrete pavement on both sides of the street from the railroad tracks north to the building walls at #24 Concord Street on the west side of the street and #17 on the east side of the street.

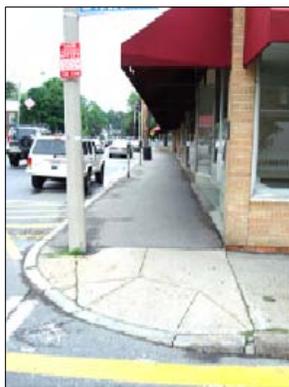
Between #117 Concord Street and ‘Made in Brasil Express’ (approx. #169 Concord) on the east side of Concord Street, the sidewalk narrows from 14’ wide to approximately 10’ wide. The cement concrete surface is in good condition. At #149 Concord, a sidewalk extension (“bumpout”) constructed in brick reduces the length of the pedestrian route at the Concord Street crosswalk linking the Memorial Building and the Arcade Building.

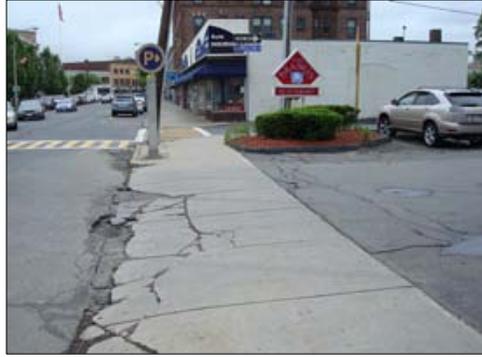
some minor pavement cracking at #42 Union and some odd pavement jointing between # 28 - #40 Union. At #26 Union, a sidewalk extension (“bumpout”) constructed in brick reduces the length of the pedestrian route at the crosswalk to the Memorial Building front entry.

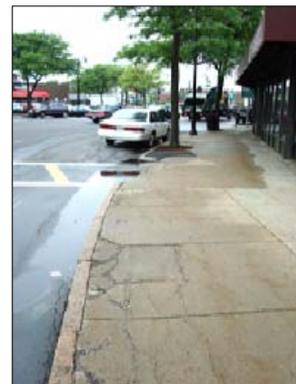
- Irving Street ramp at #22 (H&R Block) – steep ramp, poor pavement, poor drainage at gutter

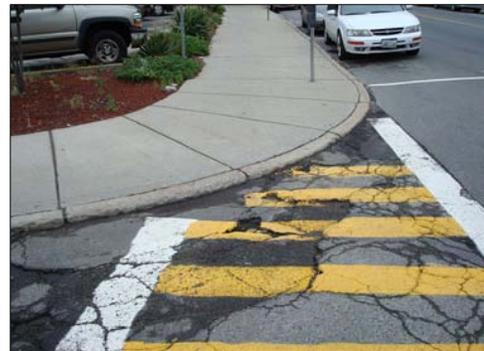
- Ramp at west side – poor drainage; ponding at base of ramp

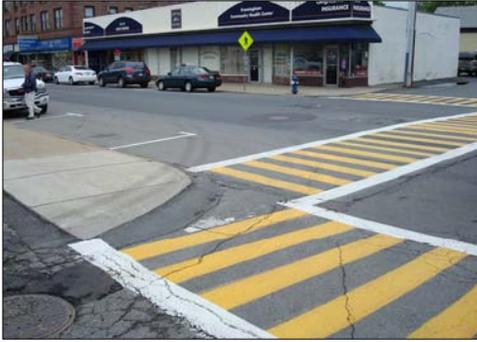
- Ramp at north corner – poor drainage; ponding at base of ramp
