# 2015 BASELINE ASSESSMENT

## SUDBURY RIVER SURVEY FINDINGS AND MANAGEMENT RECOMMENDATIONS

December 2015

Town of Framingham  
150 Concord Street  
Memorial Building-Room 213  
Framingham, MA

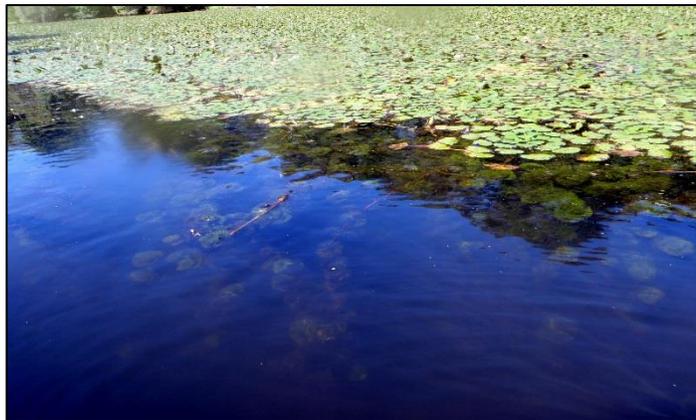
Dense fanwort growth along perimeter of water chestnut and water lily canopy

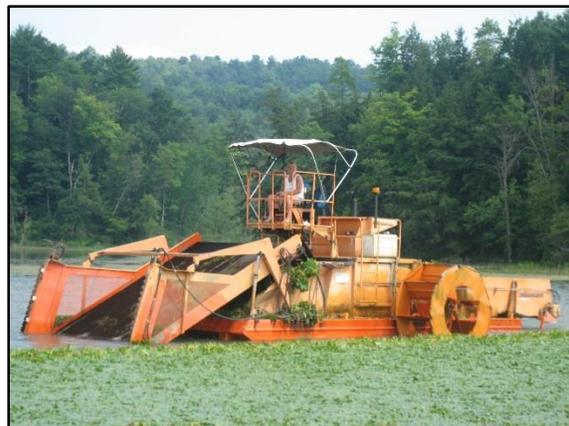
Mechanical harvesting is likely the most commonly used strategy to control water chestnut. It has been used successfully to control water chestnut infestations on the Charles River, the Mystic River, Lake Champlain, and many other sites around New England. Mechanical harvesters are paddle-wheel driven barges that cut and collect aquatic vegetation. The front cutting table can be adjusted to a maximum cutting depth of usually 5-7 feet. Hydraulically driven conveyors on these machines facilitate stockpiling and off-loading of the harvested material. By removing the water chestnut rosettes in mid to late

summer before viable seed production occurs, the plants can be prevented from successfully reproducing and the infestation reduced over time. Due to the significant biomass associated with water chestnut the shore-based disposal operation is a critical component of an efficient and successful harvesting project.

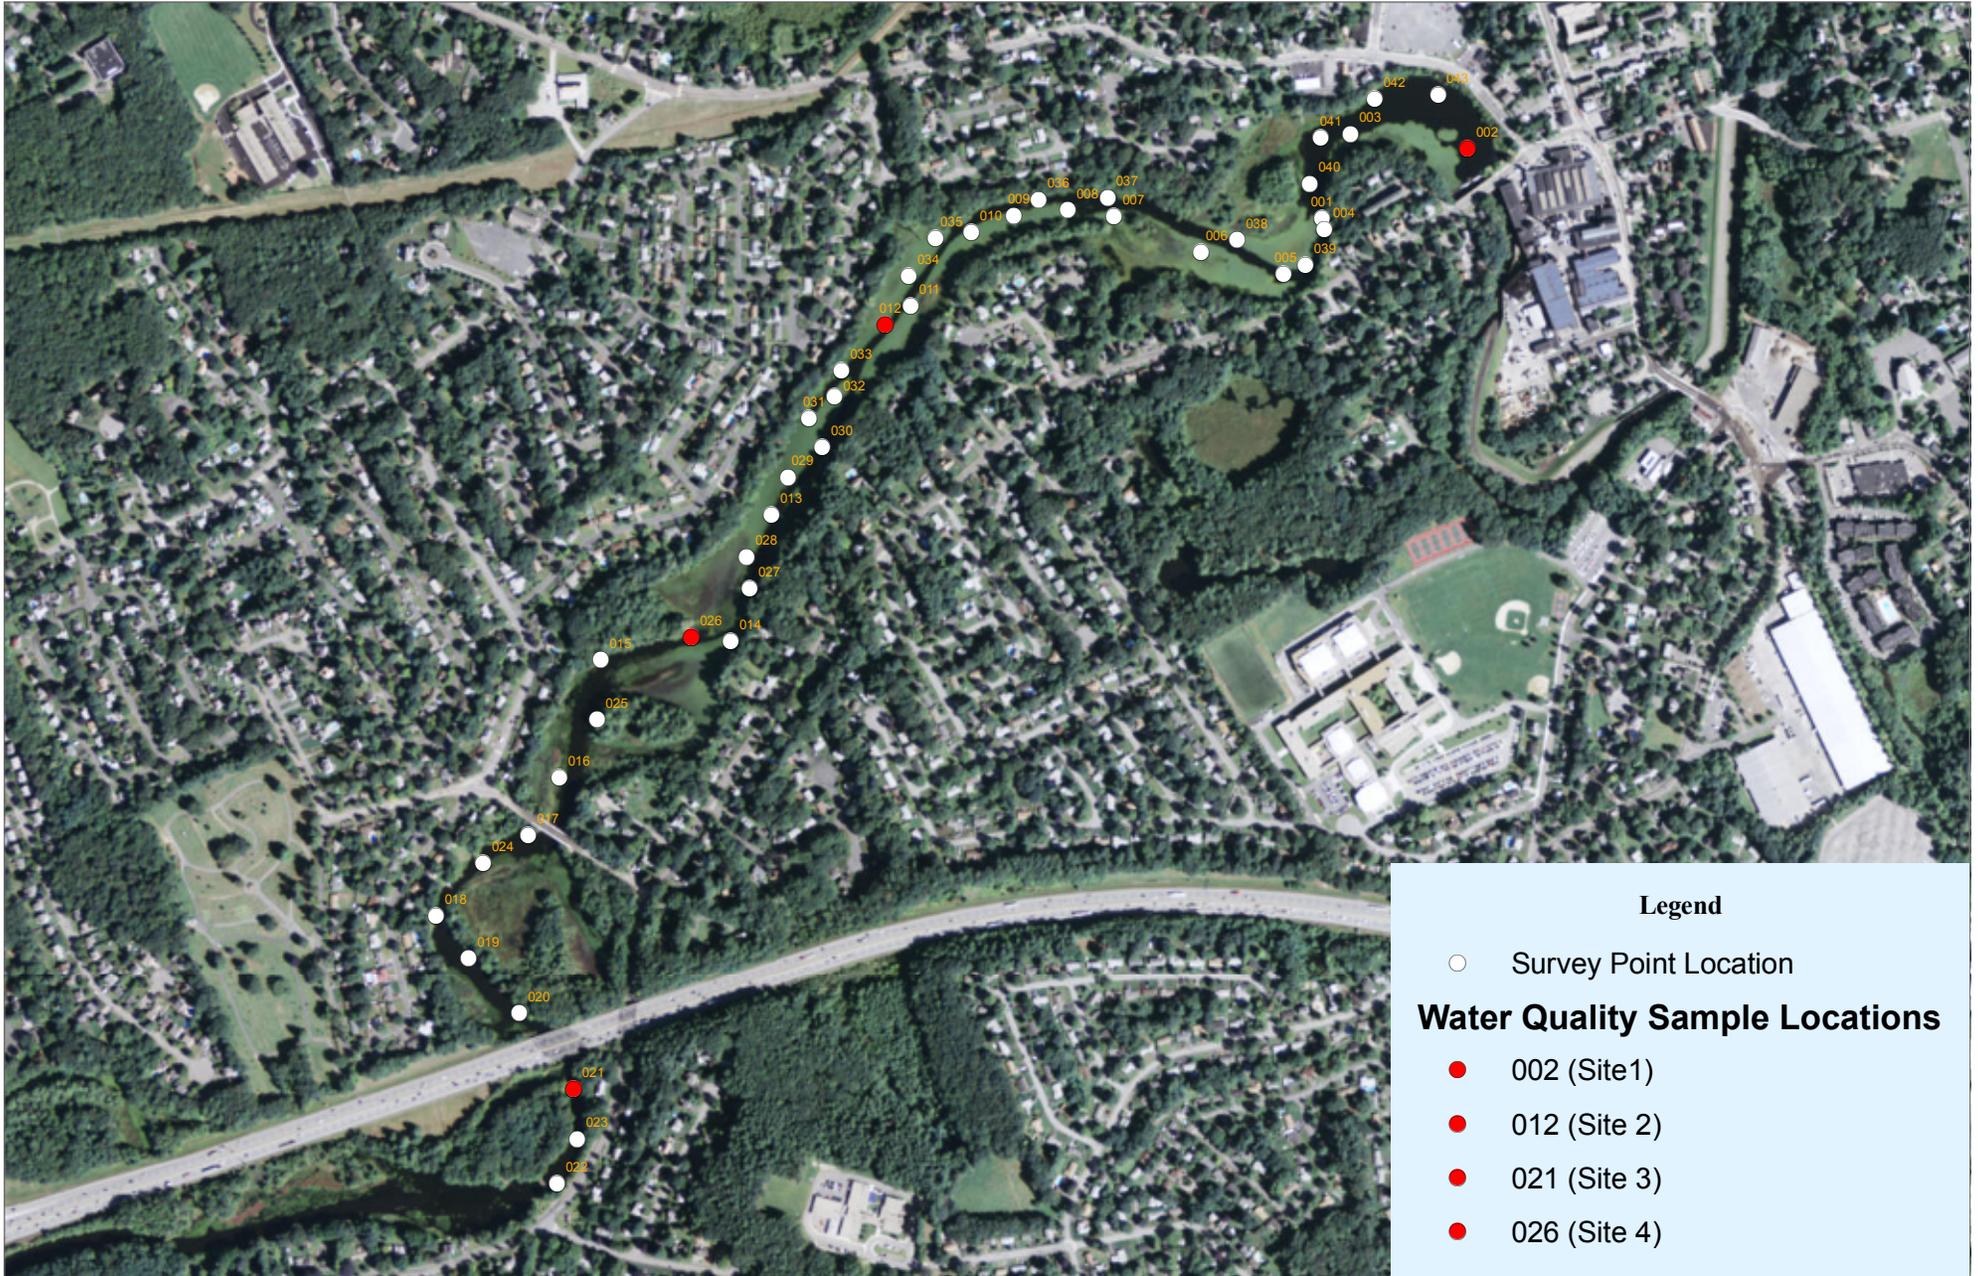
# Survey Point and Water Quality Sample Locations

*Figure 1 – Survey Point and Water Quality Sample Locations*

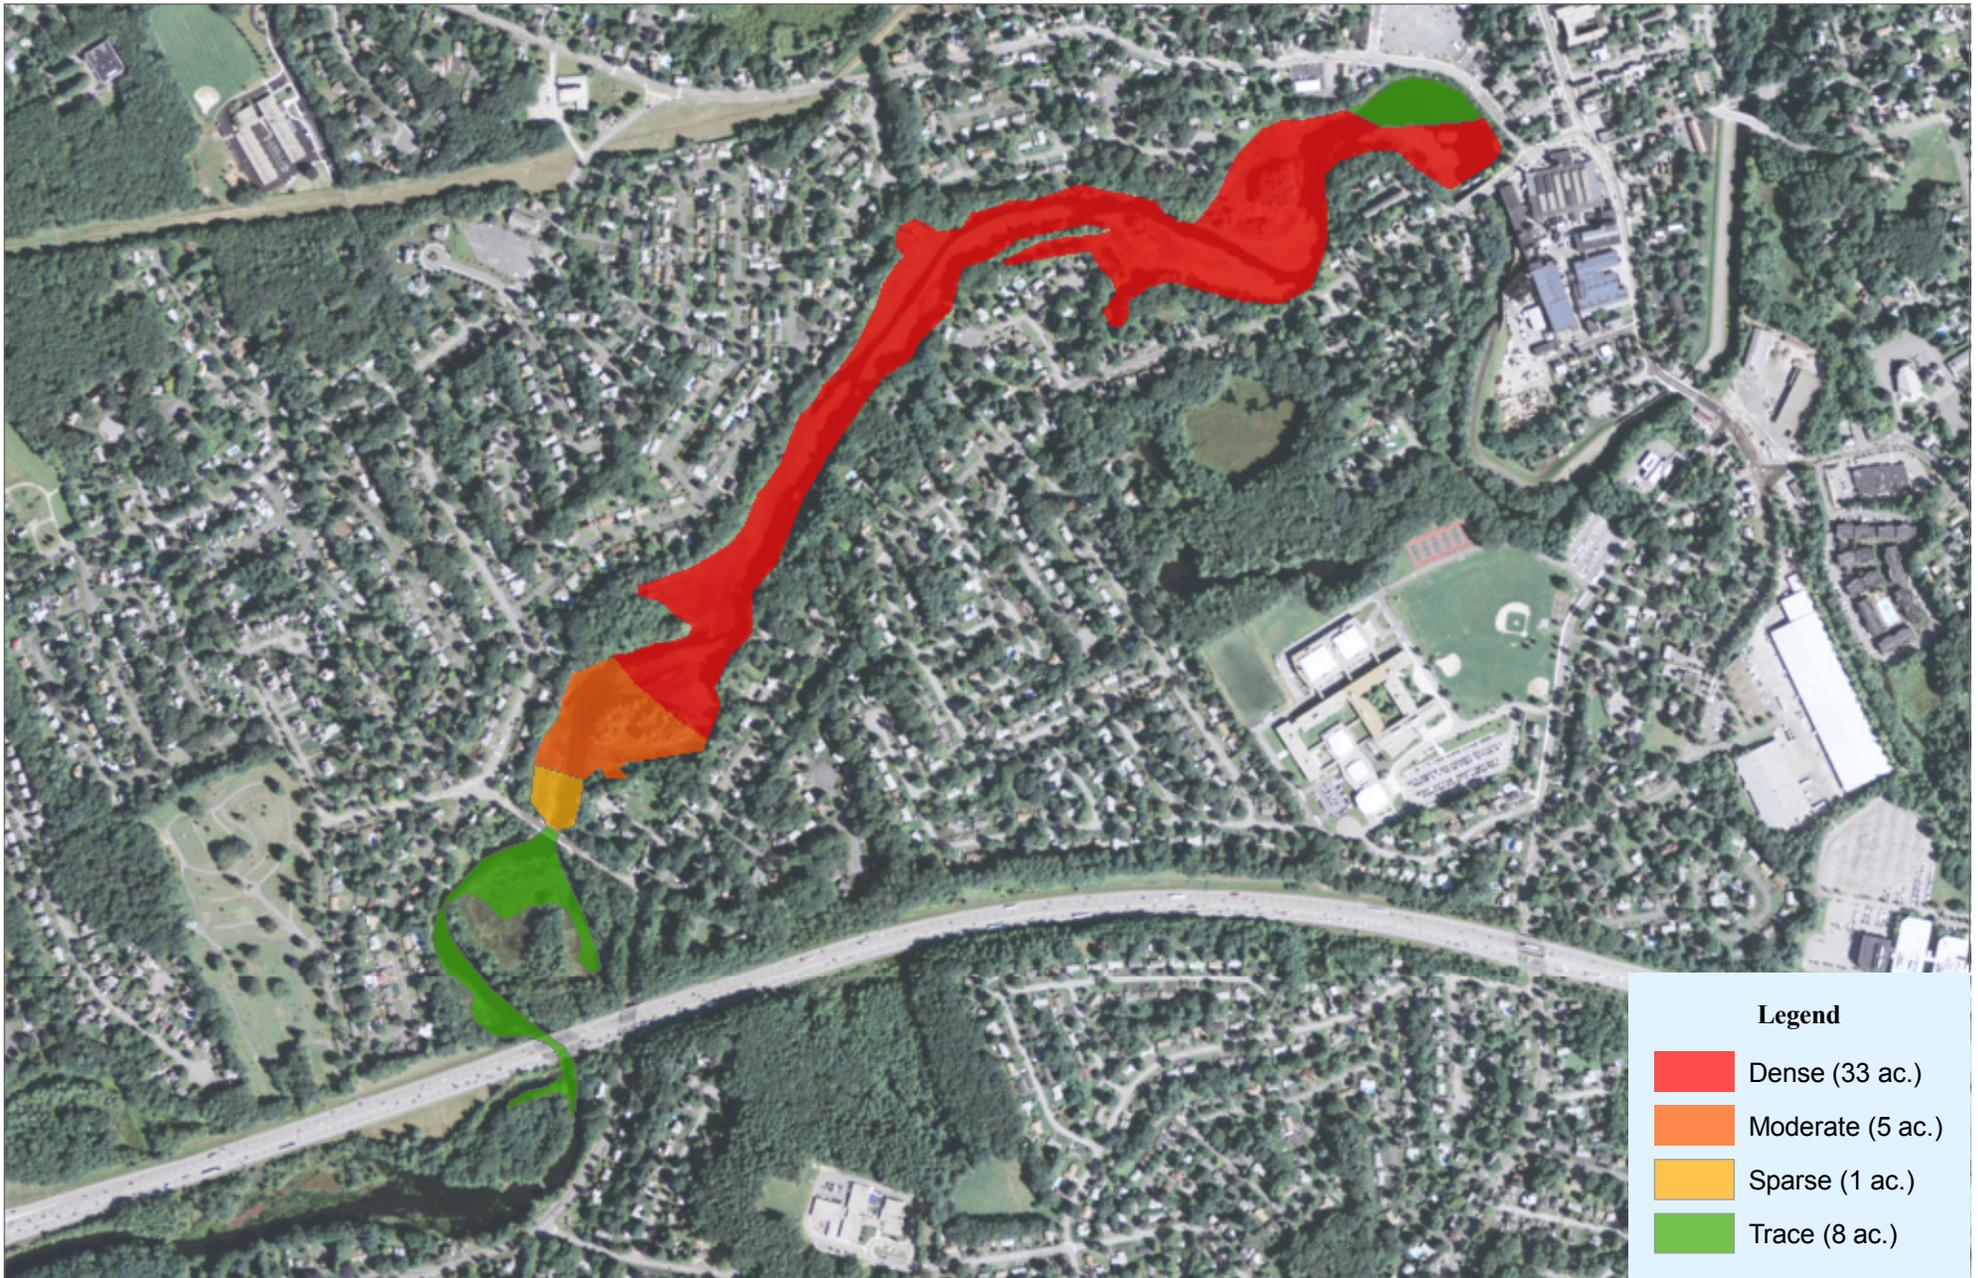
# Distribution and Relative Abundance of *Trapa natans*

At the time of the August survey, it was visually clear that non-native water Chestnut (*Trapa natans*) dominates the aquatic plant growth in the ponded section of the river (See 'Distribution & Relative Abundance of *Trapa natans*'). In fact, water chestnut was the only plant species that was recorded at all 38 of the recorded data points. The chestnut growth consisted of dense contiguous beds that covered more than 85% of the surface area of the river section. Only a narrow channel of open water remained in most areas of the study area.

*Figure 2 – Trapa natans Distribution and Relative Abundance*

By far water chestnut is the most abundant and problematic plant currently growing in the study area. We, therefore, feel that the first phase of the management program should focus on the control of this species. Water chestnut is an annual seed producing plant that can be effectively managed through both mechanical and chemical strategies. Regardless of the management technique employed, long-term control of water chestnut requires a multi-year commitment, as the goal of active management is to annually prevent viable seed production until the dormant seed-bank is depleted. Water chestnut seeds can remain dormant for as long as 10 years before germinating, although typically 3-5 years of large scale annual management is sufficient to reduce the infestation to the point that the management effort can be reduced.

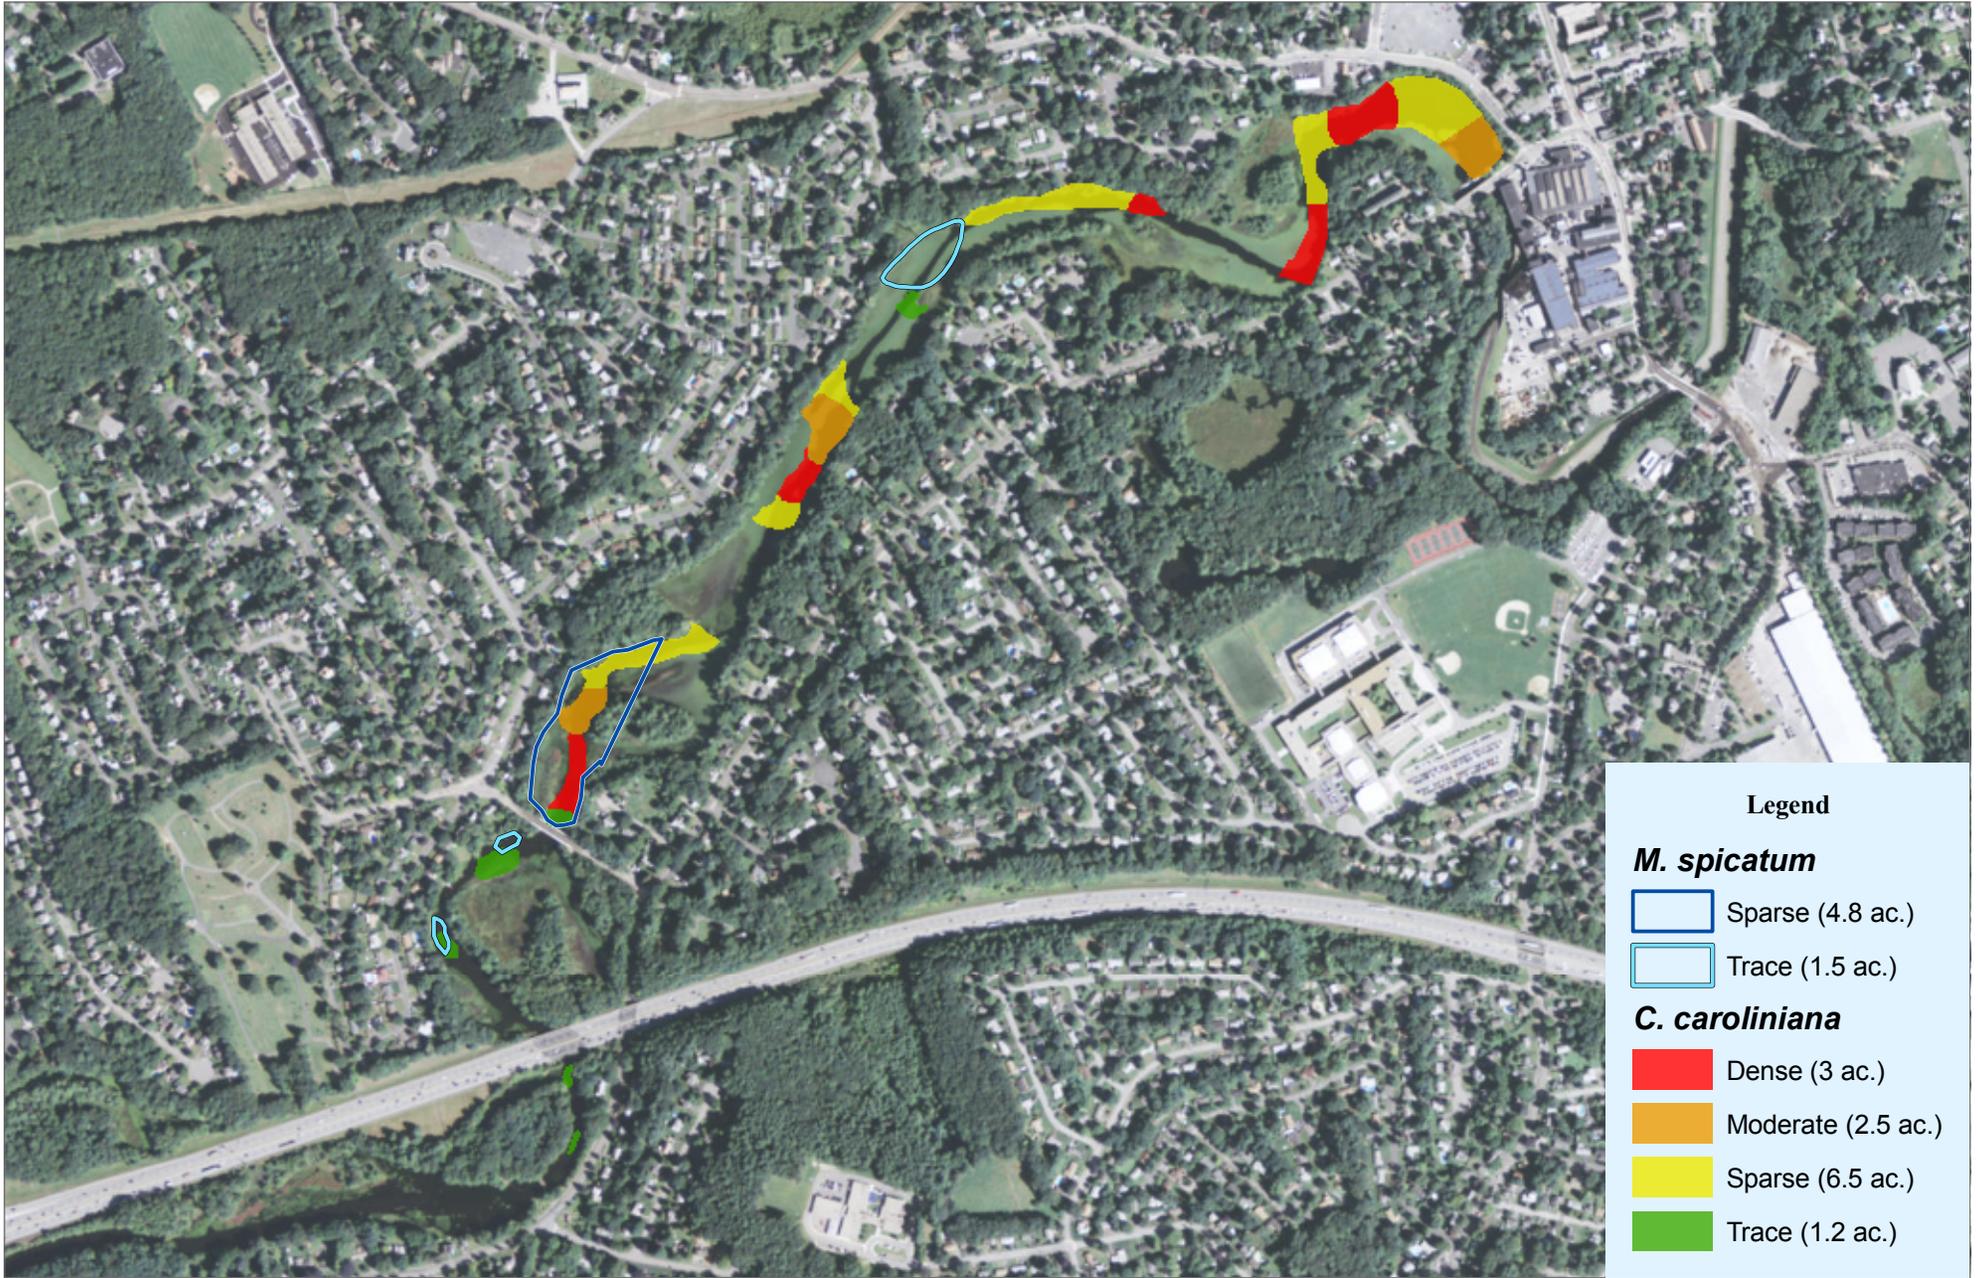
# Distribution and Relative Abundance of Submersed Invasive Vegetation

In addition, to the water chestnut, the study area also supported the growth of non-native variable watermilfoil (*Myriophyllum heterophyllum*), Eurasian watermilfoil (*Myriophyllum spicatum*), and fanwort (*Cabomba caroliniana*). These species were present at much lower densities and at far more limited distribution than the water chestnut. The milfoil growth was only found in a few locations throughout the study area and density was generally considered to be sparse to trace. The fanwort, however, was observed growing in defined beds that coincided with areas of lower chestnut density. In the areas where fanwort growth was observed, the density ranged from moderate to dense.

*Figure 3 – Submersed invasive Species Distribution and Relative Abundance*

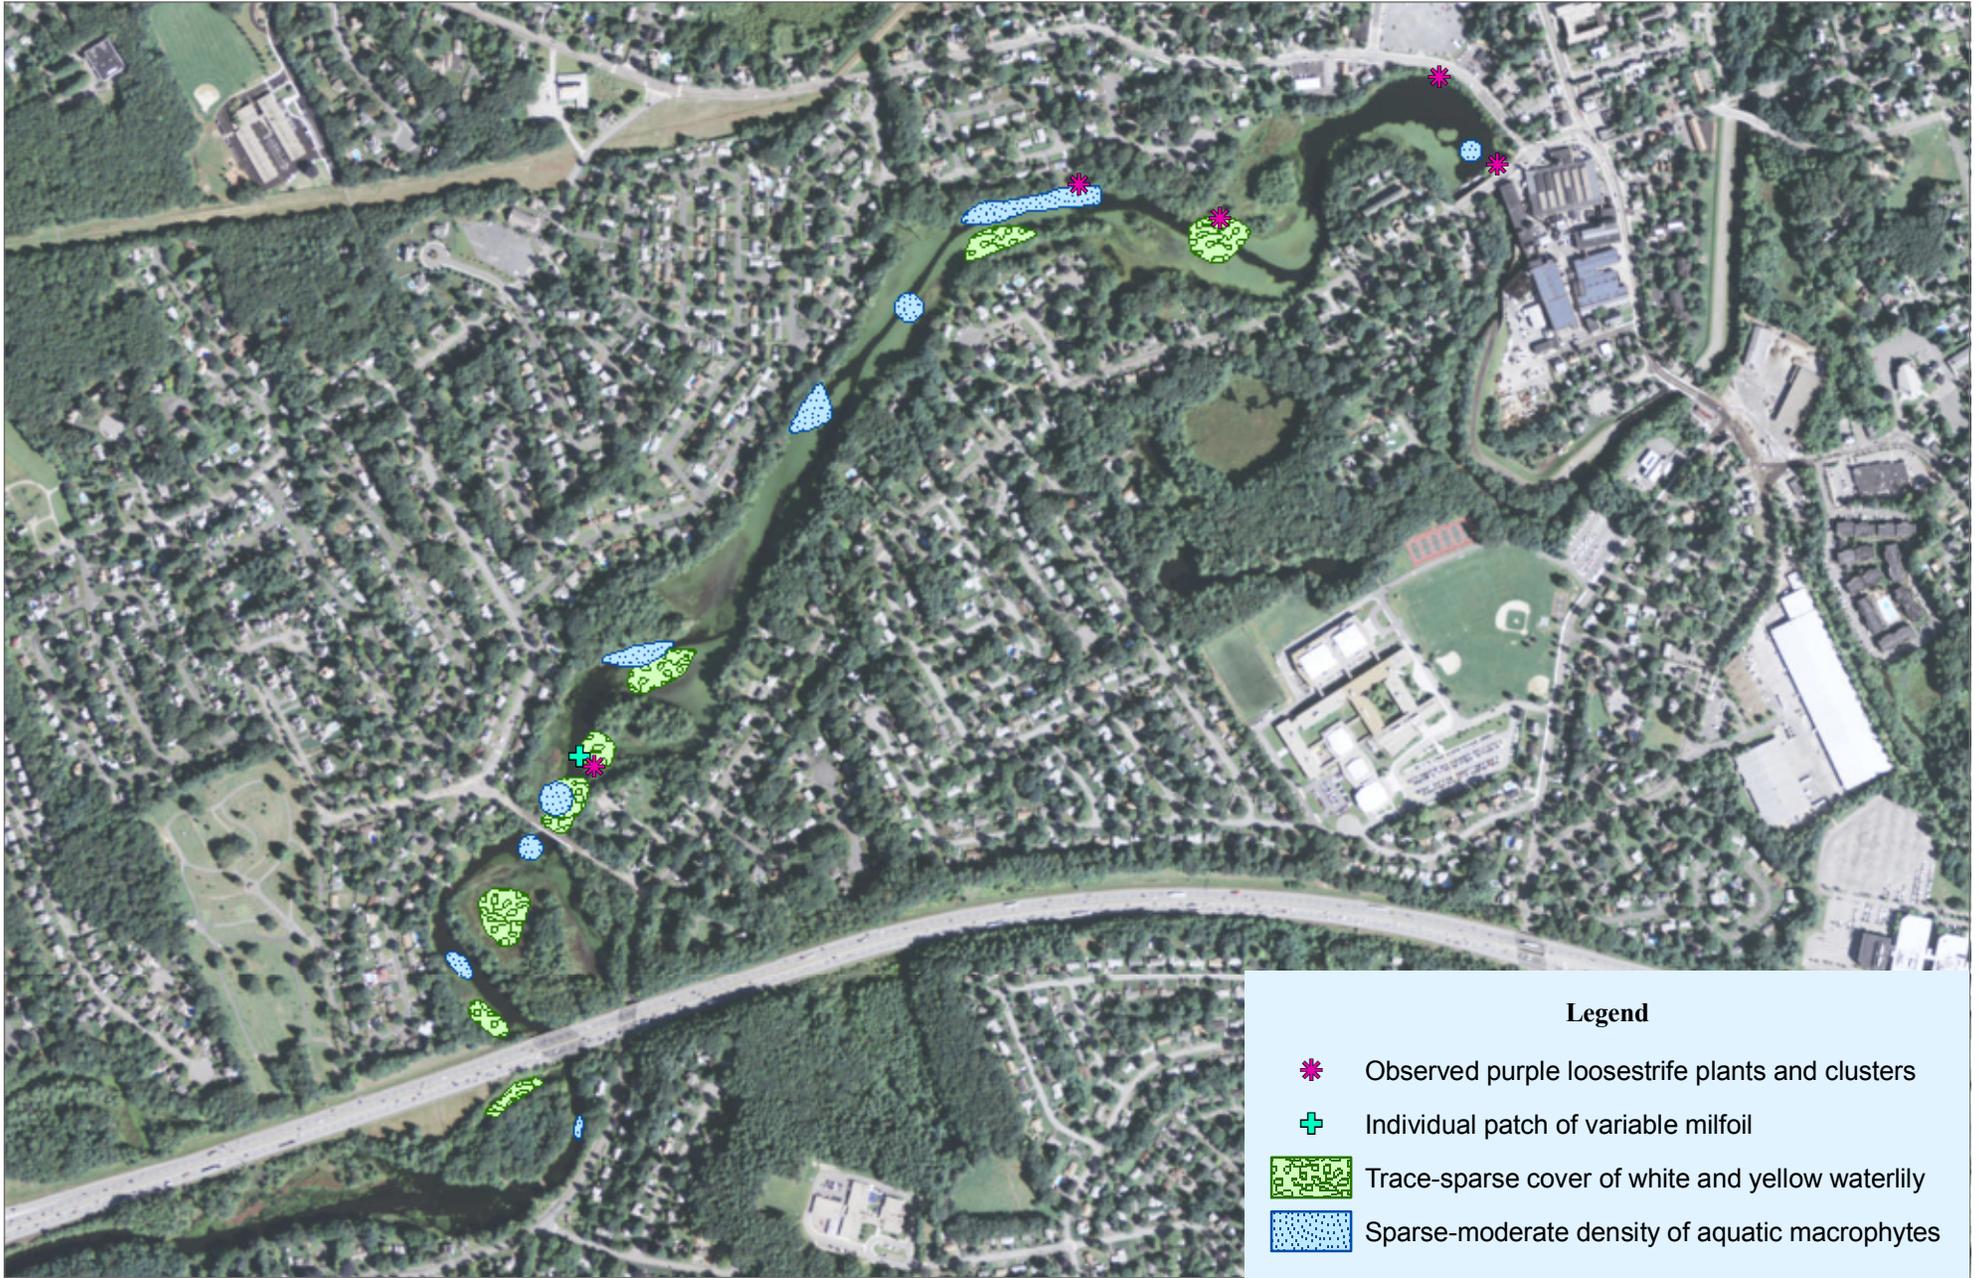
# Distribution of Other Recorded Species

*Figure 4 – Distribution of Other Recorded Species*

- \* Observed purple loosestrife plants and clusters
- + Individual patch of variable milfoil
- Trace-sparse cover of white and yellow waterlily
- Sparse-moderate density of aquatic macrophytes
