FRAMINGHAM DOWNTOWN PROGRAMMATIC STUDY
TECHNICAL MEMORANDUM ON EXISTING CONDITIONS

Technical Memorandum #1 - Existing Surface Conditions/Deficiencies

Prepared by: The Cecil Group, Inc.
Prepared for: BETA Group, Inc. and
Town of Framingham

June, 2008

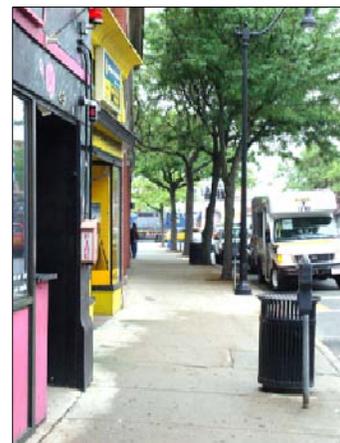
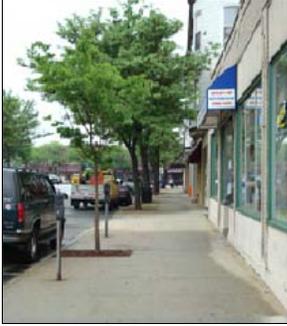
On the east side of Hollis Street, the sidewalk varies from 12-13 feet wide between the building face and curb face and constructed

of cement concrete. The sidewalk surface is in very good condition, with some visual variation due to panels being poured and /or repaired at a variety of times. While the sidewalk has a nearly imperceptible slope in both transverse and longitudinal directions, it drains well and exhibits little cracking or deterioration.

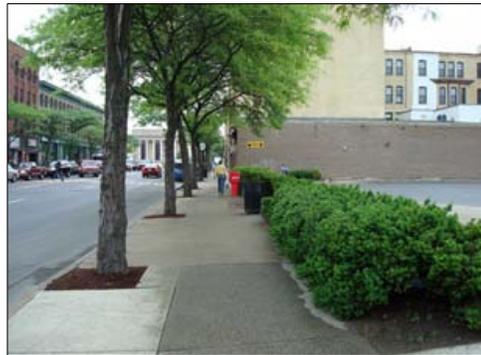
On the east side of Concord Street from #17 to the Howard Street intersection, the sidewalk surface is cement concrete. The pedestrian zone is approximately 12 feet in width, has a gentle crosspitch and is in acceptable condition.

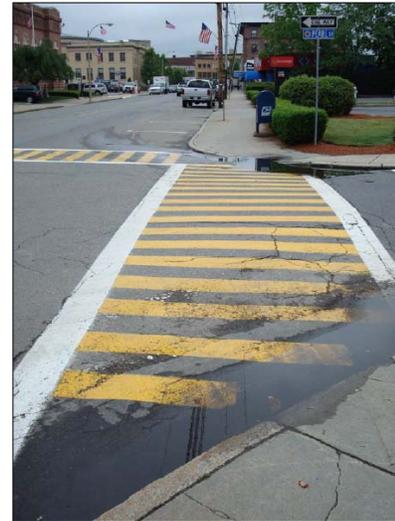
Union Avenue/Pearl Street Intersection

- Ramp at SE intersection corner – poor drainage, ponding at base of ramp; two crosswalks share single ramp
- Ramp at NE intersection corner – poor drainage, ponding at base of ramp
- Ramp at SW intersection corner – poor drainage, ponding at base of ramp; two crosswalks share single ramp
- Ramp at NW intersection corner – poor drainage, ponding at base of ramp

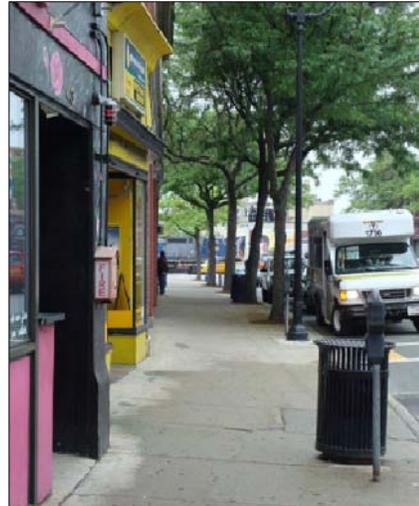
Entry Not Accessible

- #93 Hollis Street
- #85-91 Hollis Street
- #75 Hollis Street
- #73 Hollis Street
- #61-63 Hollis Street
- #59 Hollis Street
- #57 Hollis Street
- #55 Hollis Street
- #53 Hollis Street
- #51 Hollis Street
- #49 Hollis Street

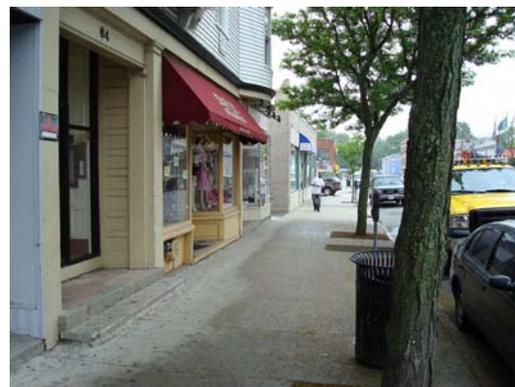
Entry Not Accessible

- #68 Hollis Street
- #66 Hollis Street
- #64 Hollis Street
- #60-62 Hollis Street
- #52 Hollis Street
- #46 Hollis Street
- #44 Hollis Street
- #40 Hollis Street
- #36 Hollis Street
- #30 Hollis Street
